Malšice, Tábor, South Bohemian Region

Medieval castle 'Příběnice'

(13th–15th cent.)

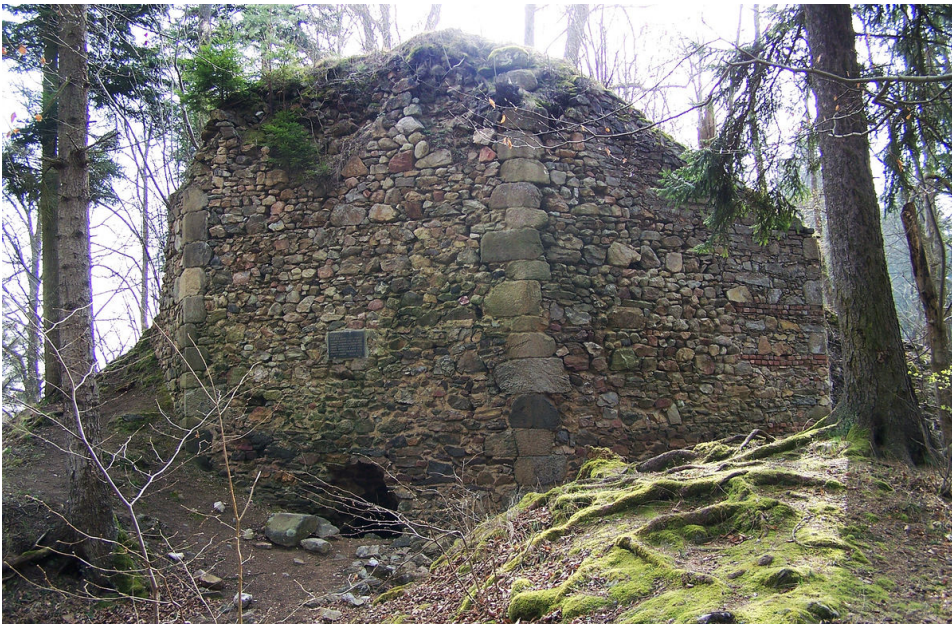
Remains of a bergfrit.

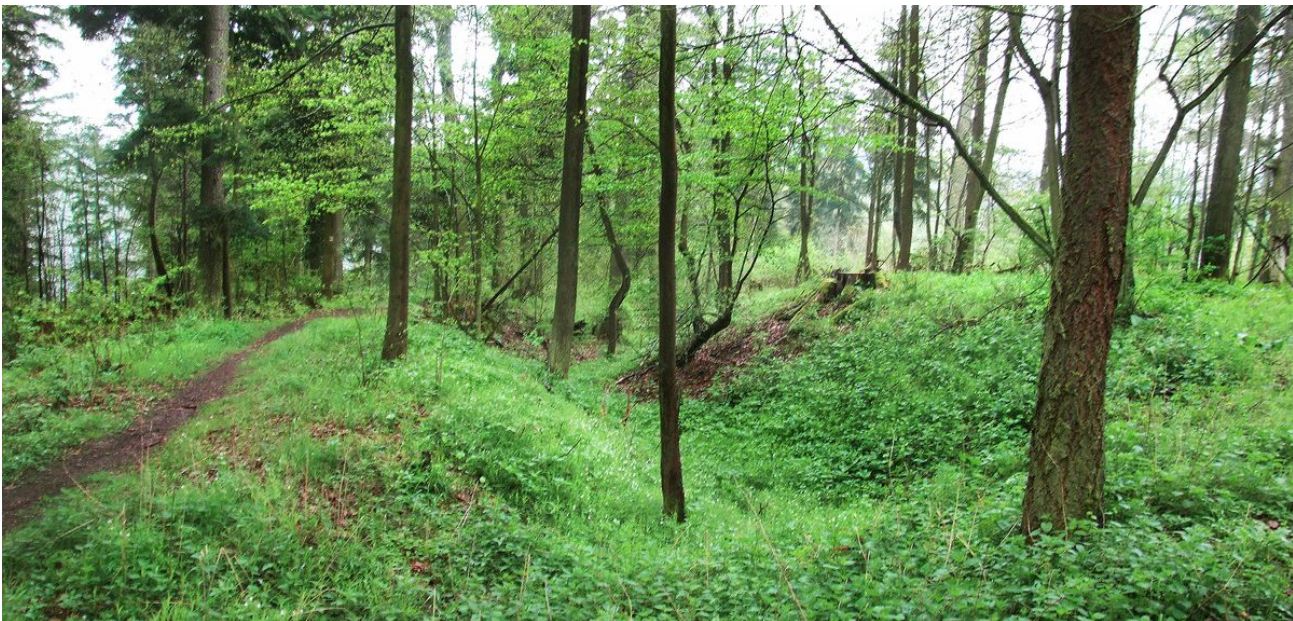
A hollow way leading from the first gateway to the castle's core.

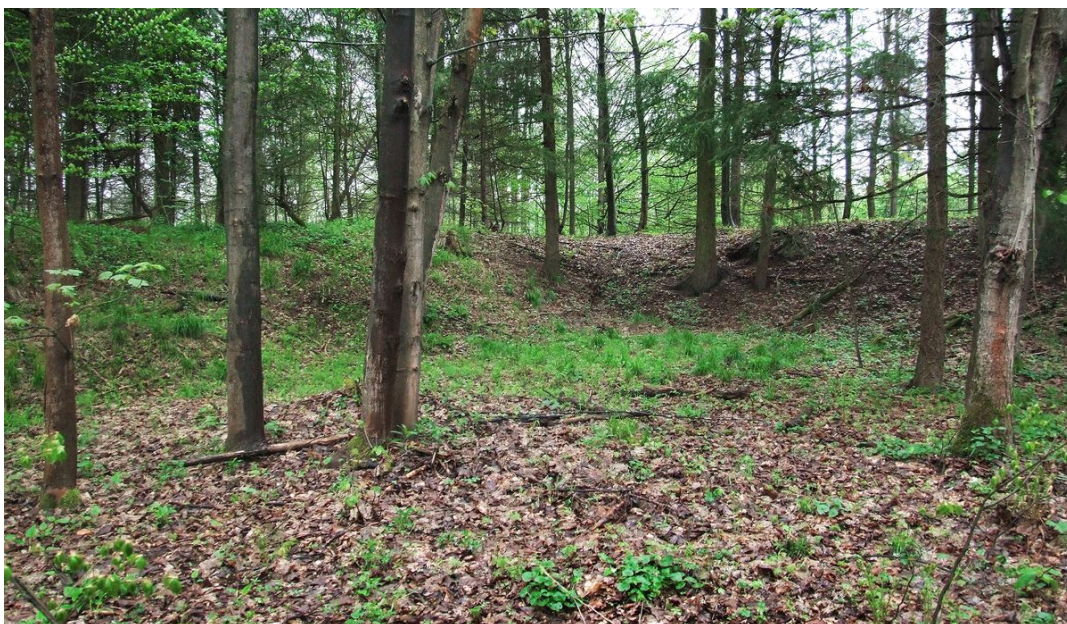
Traces of siege works in the castle's foreground.

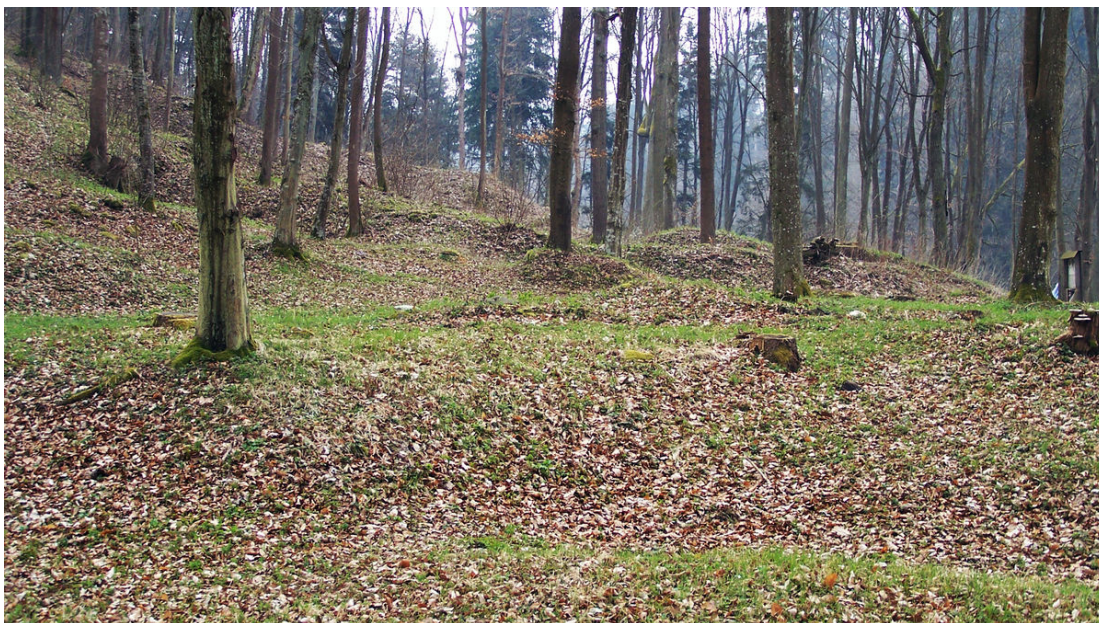
Bailey with a deserted hollow way.
