Prague-Kunratic, Prague

Medieval castle 'Nový hrad' u Kunratic and siege camp

(15th cent.)

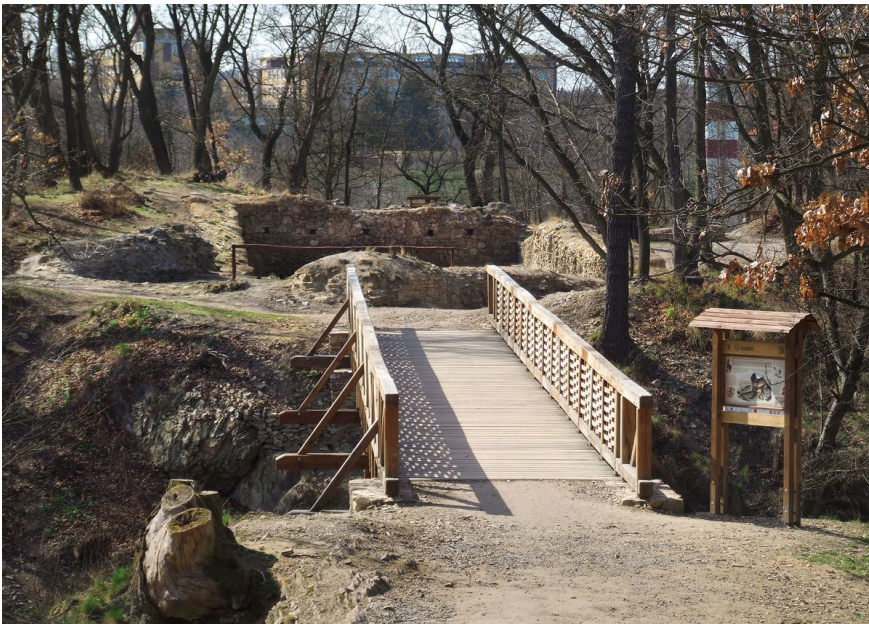
Castle core with a cellar of the tower-like palace. View from north-east, across the moat.
Photo J. Hložek, 2014.

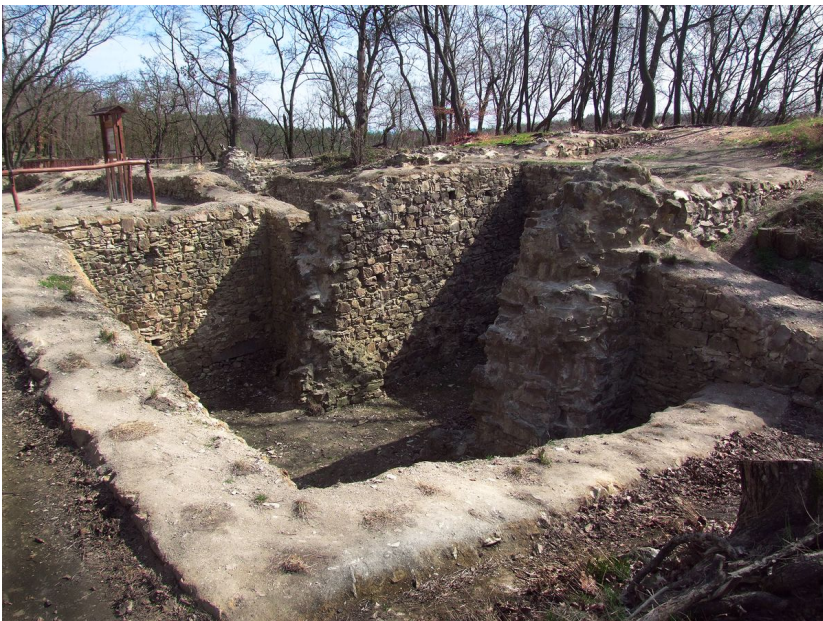
Second gate with a walled-in moat.
Photo J. Hložek, 2014.

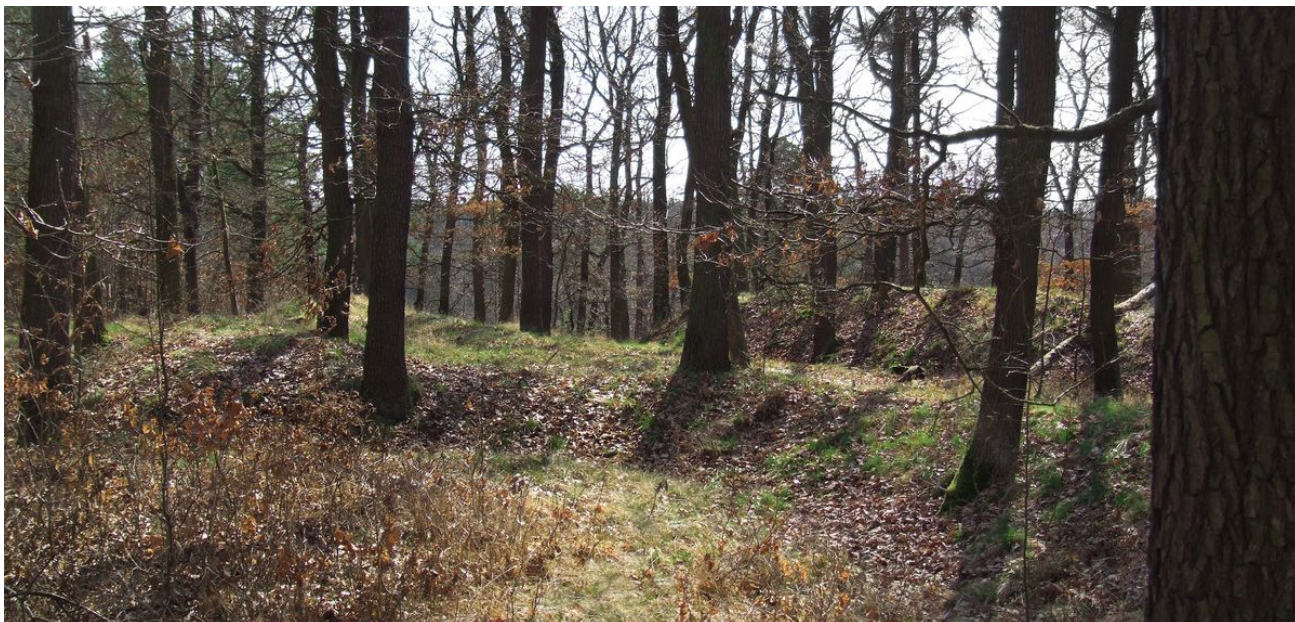
Northeastern fortification of the siege camp.

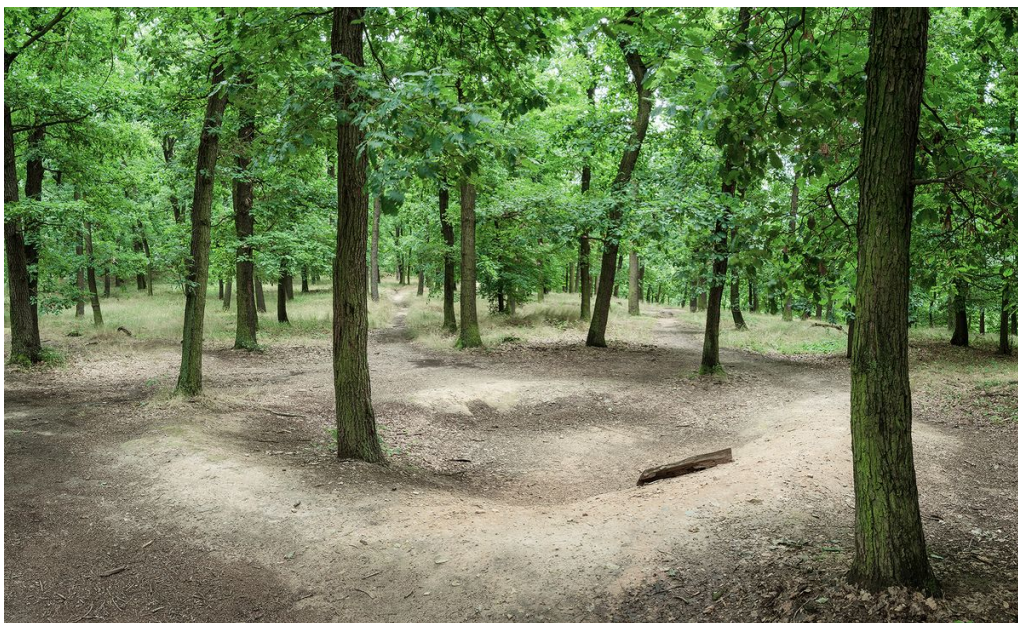
Surface relicts of buildings belonging to the siege camp.

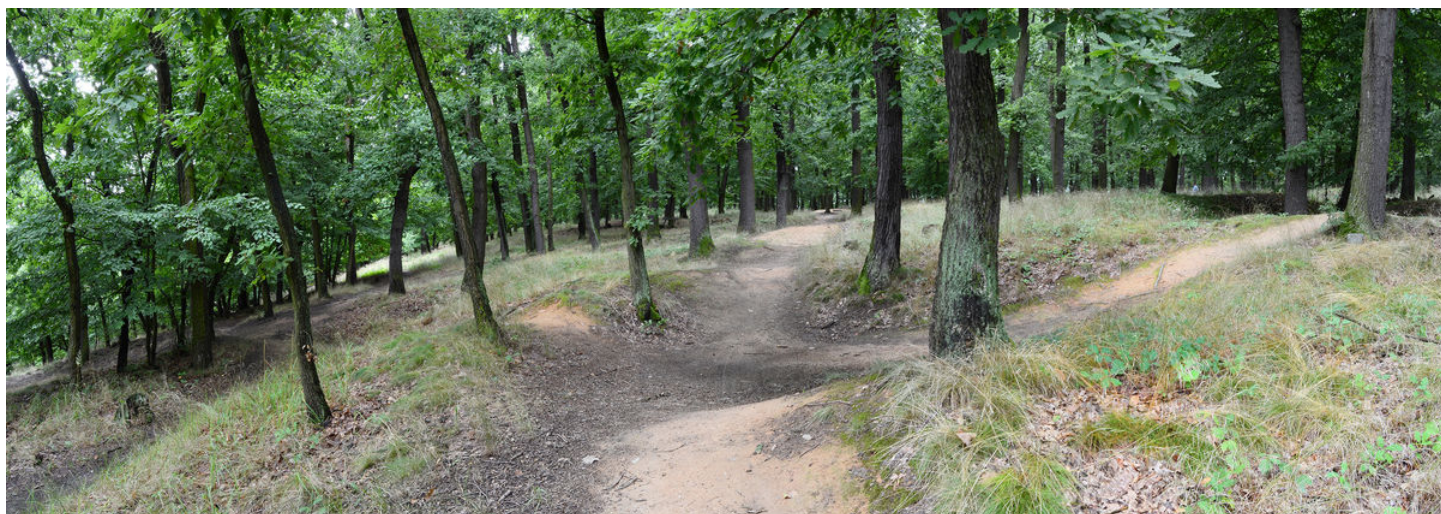
Built-up area of the siege camp.
