# Holštejn, Blansko District, South Moravian Region

Prehistoric cave, ruin of the medieval castle of Holštejn and deserted settlement

(2900 BC–15th cent. AD)

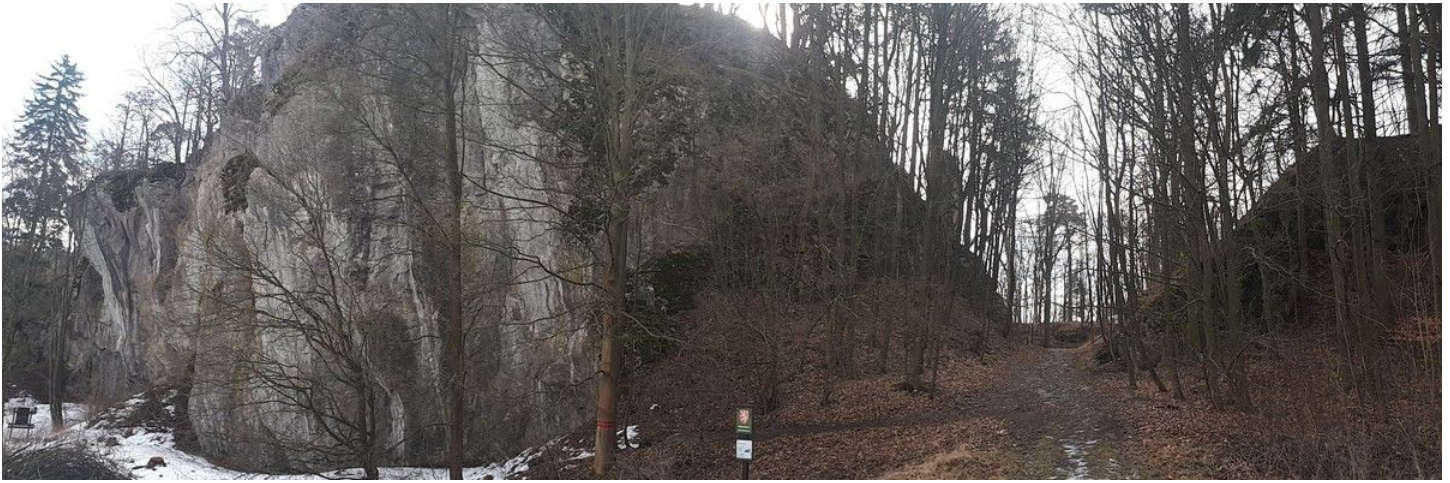
View of the rock spur from the north-west with a high rock wall, which exceeds 30 metres; on the right is the western ditch carved into the stone.

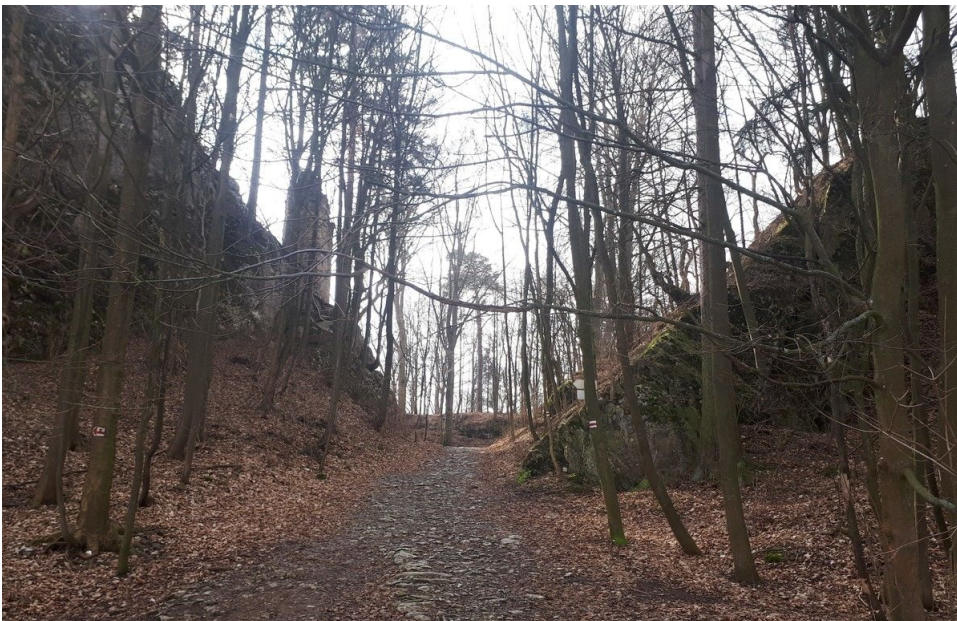
An artificially modified crevice below the west part of the castle core; on the left, there are the remains of the south-western castle corner, which is today the dominant feature (height of the ruin: 8.5 m).

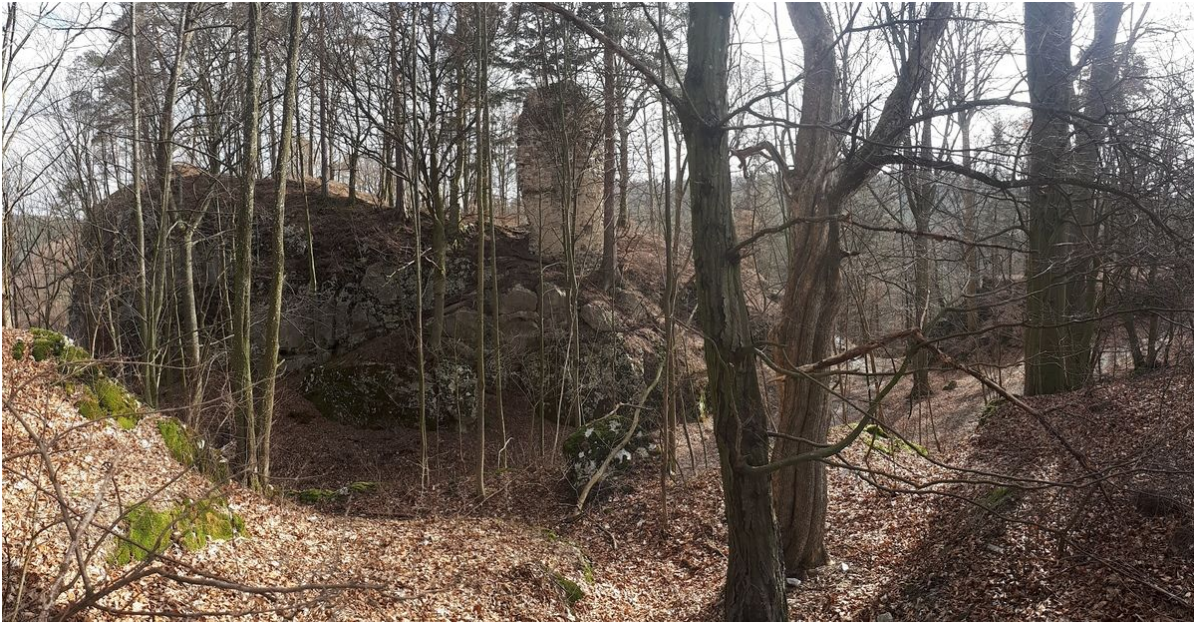
View of the castle ruin of Holštejn from the west; on the left there is the elevated core of the castle with the remains of the south-western corner; the area on the right was a small outer bailey, which with a drawbridge, served as an entrance to the castle.

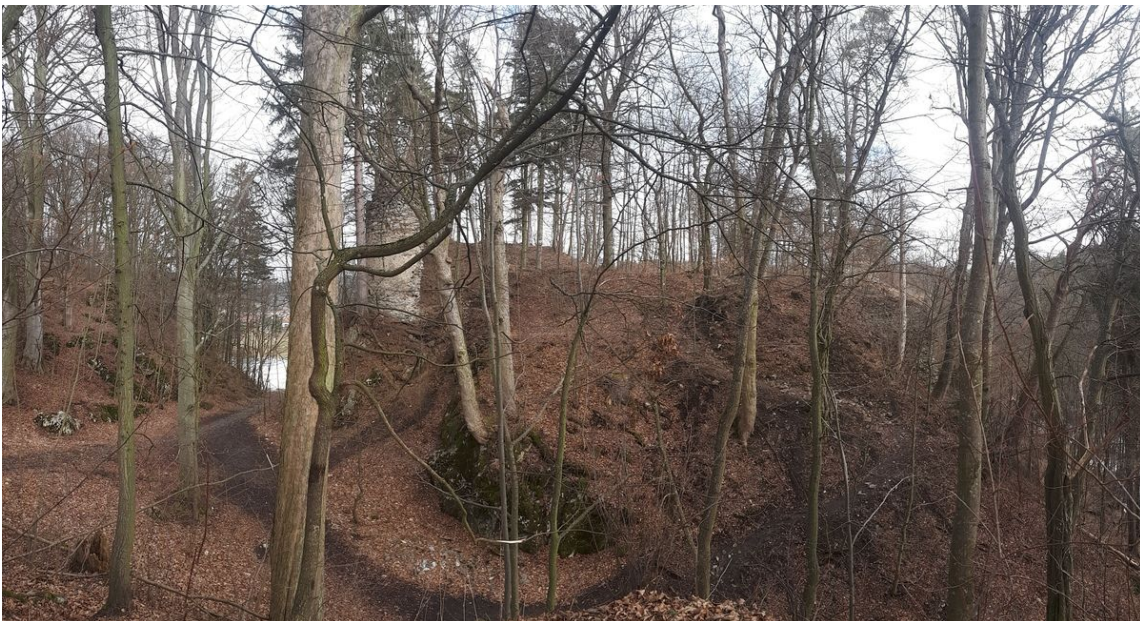
Overall view of the centre of the castle with the entrance area; the south-western (on the left) and the south-eastern (on the right) castle corners are visible.

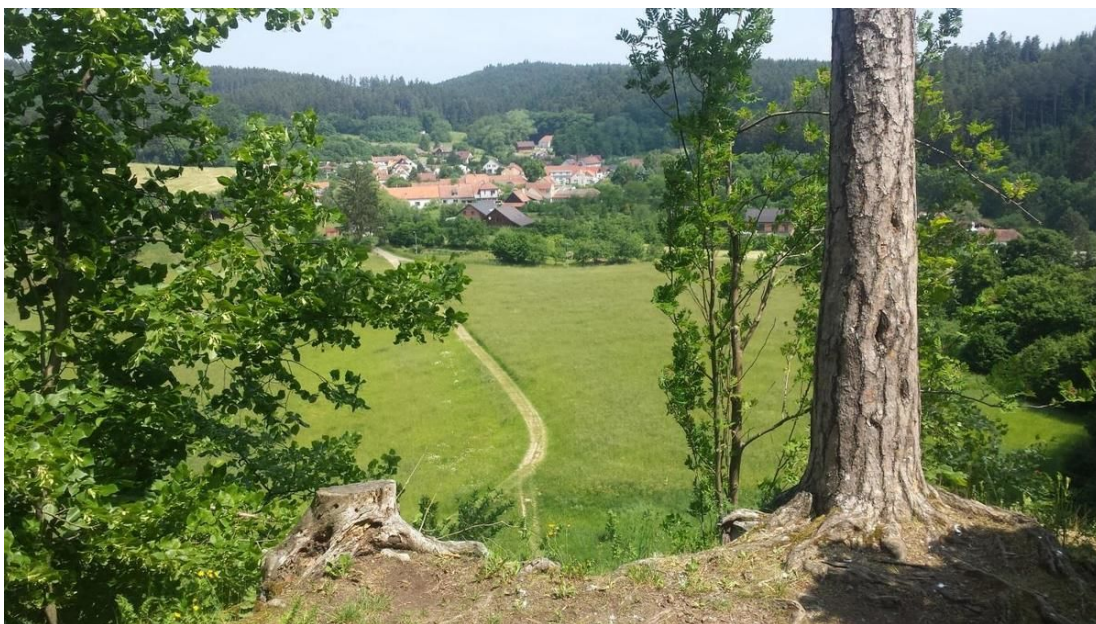
Overall view from the south of the deserted settlement (Na Městečku site) from the former residential building of the castle.

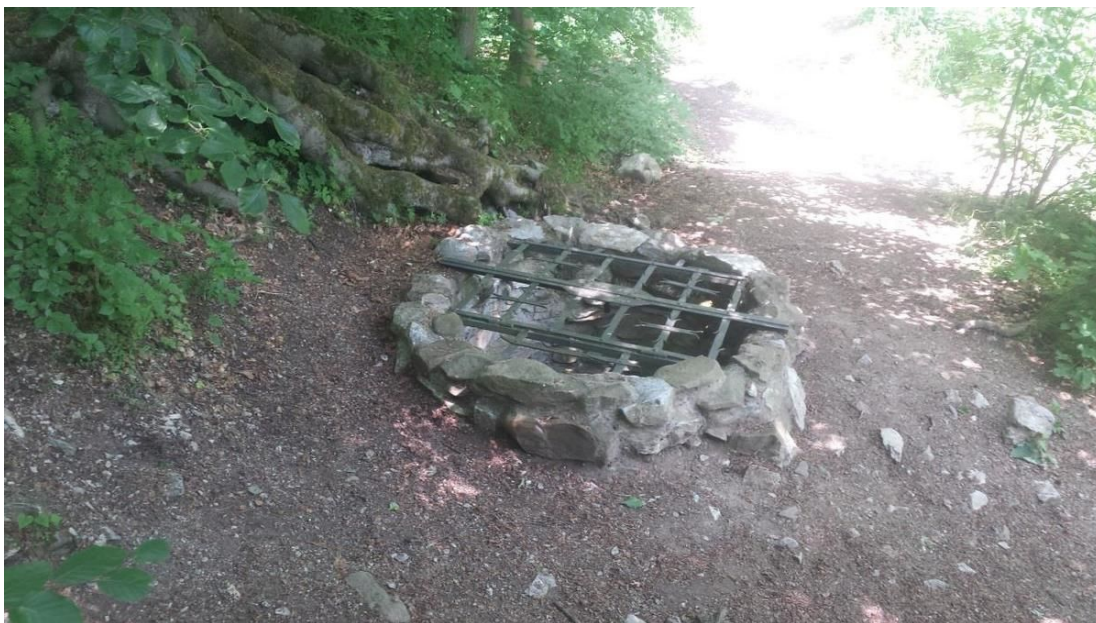
The exit of the alleged passage from Holštejn Castle to Hladomorna Cave.
