# Pořešín, Český Krumlov dist., South Bohemian Region

## Medieval castle

(13th–15th cent.)

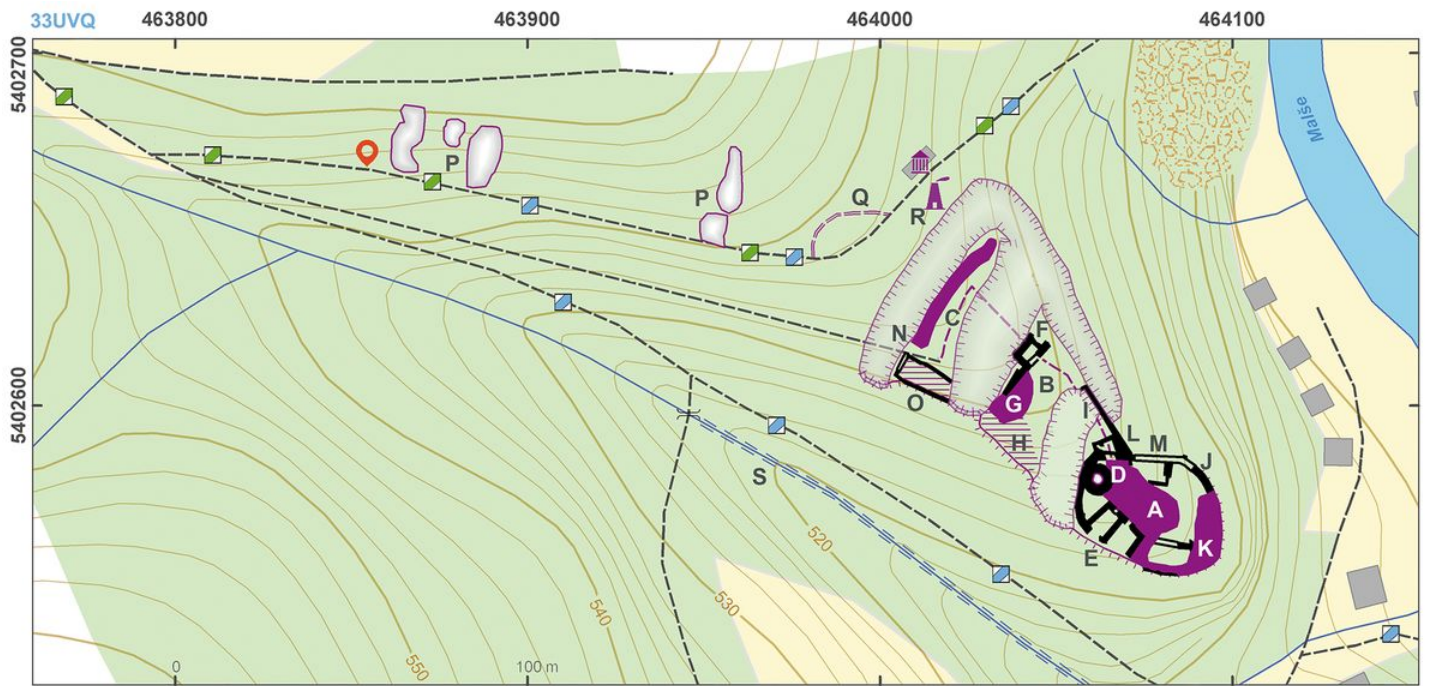
**Map notes:** A – castle; B–C – baileys; D – keep; E – two-compartment palace; F – tower gateway; G – remnant of stone structure; H – platforms left after above-ground structures; I – mouth of the third ditch, later protected by a wall; J – defensive wall around the centre of the castle; K – buildings attached to the wall; L – third gate; M – kitchen; N – stone bridge support; O – building, the upper floor of which was insulated by a wattle construction; P – quarries for building stone; Q – hollow ways; R – remains of a limestone kiln; S – remains of a millrace.

Site plan.

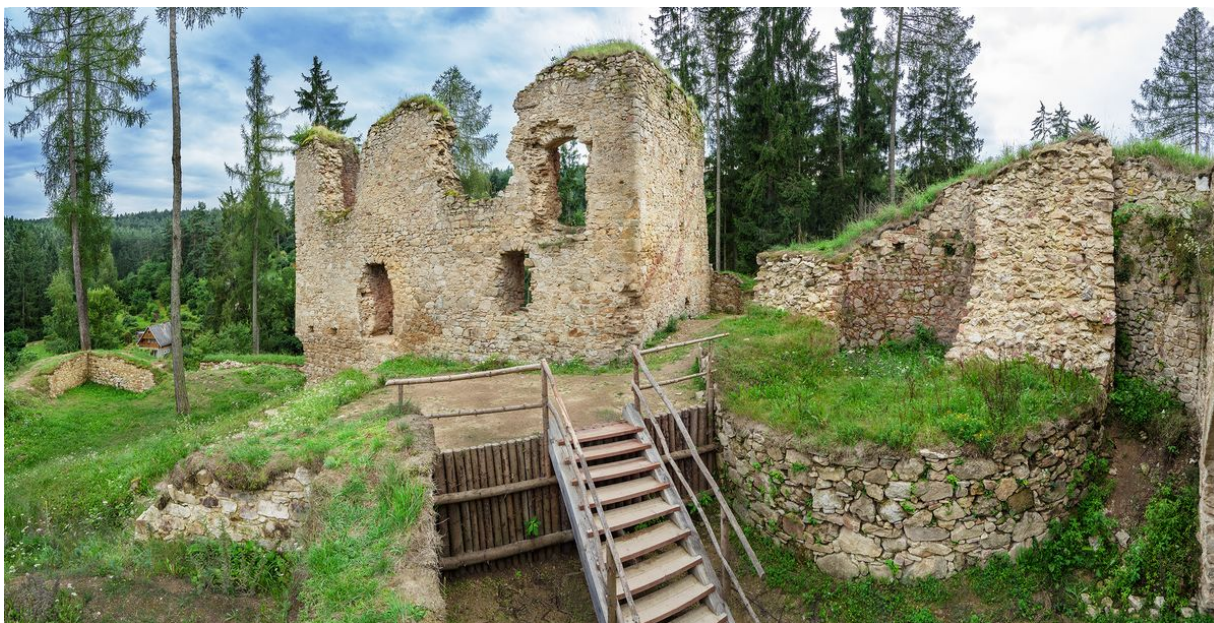
Castle core from north. Wall of the earliest castle palace, ruin of a bergfrit (right).

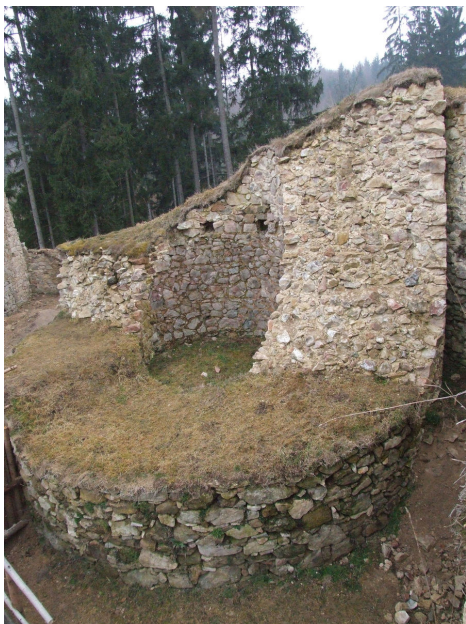
Remains of a bergfrit.

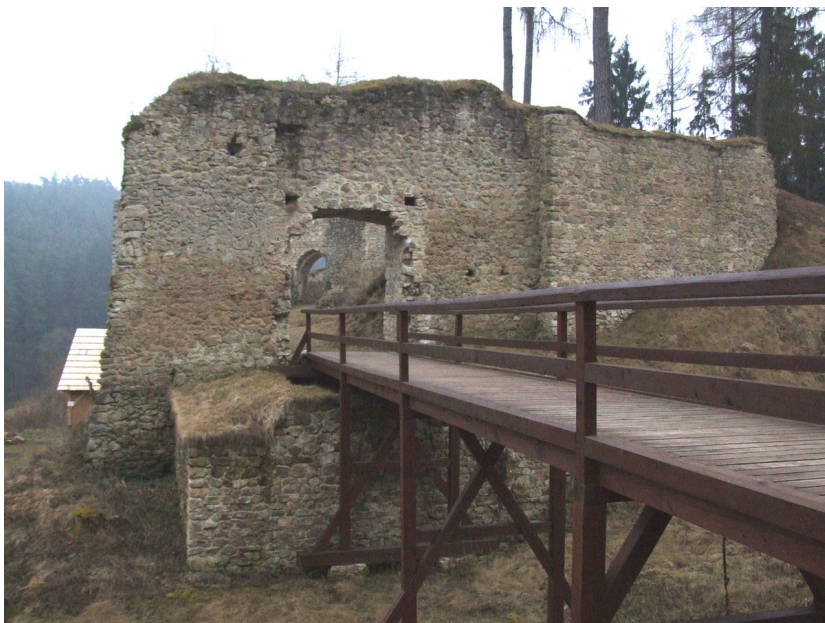
Second gate.

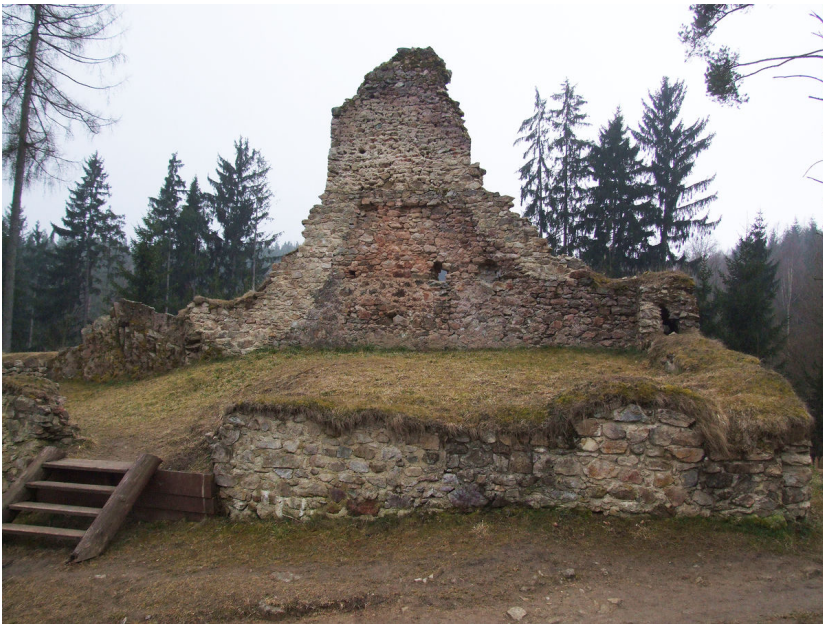
Otisk zateplené komory v prvním patře budovy na prvním předhradí.  
Foto J. Hložek, 2006.

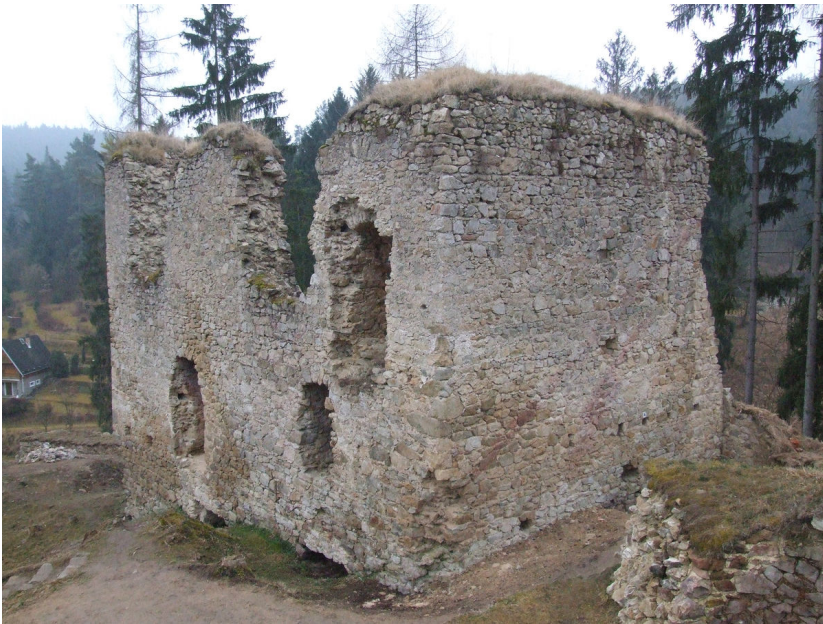
Probably the earliest palace of the castle core.
