Drnek, Kladno dist., Central Bohemian Region

Deserted Medieval village 'Svídna'

(14th–15th cent.)

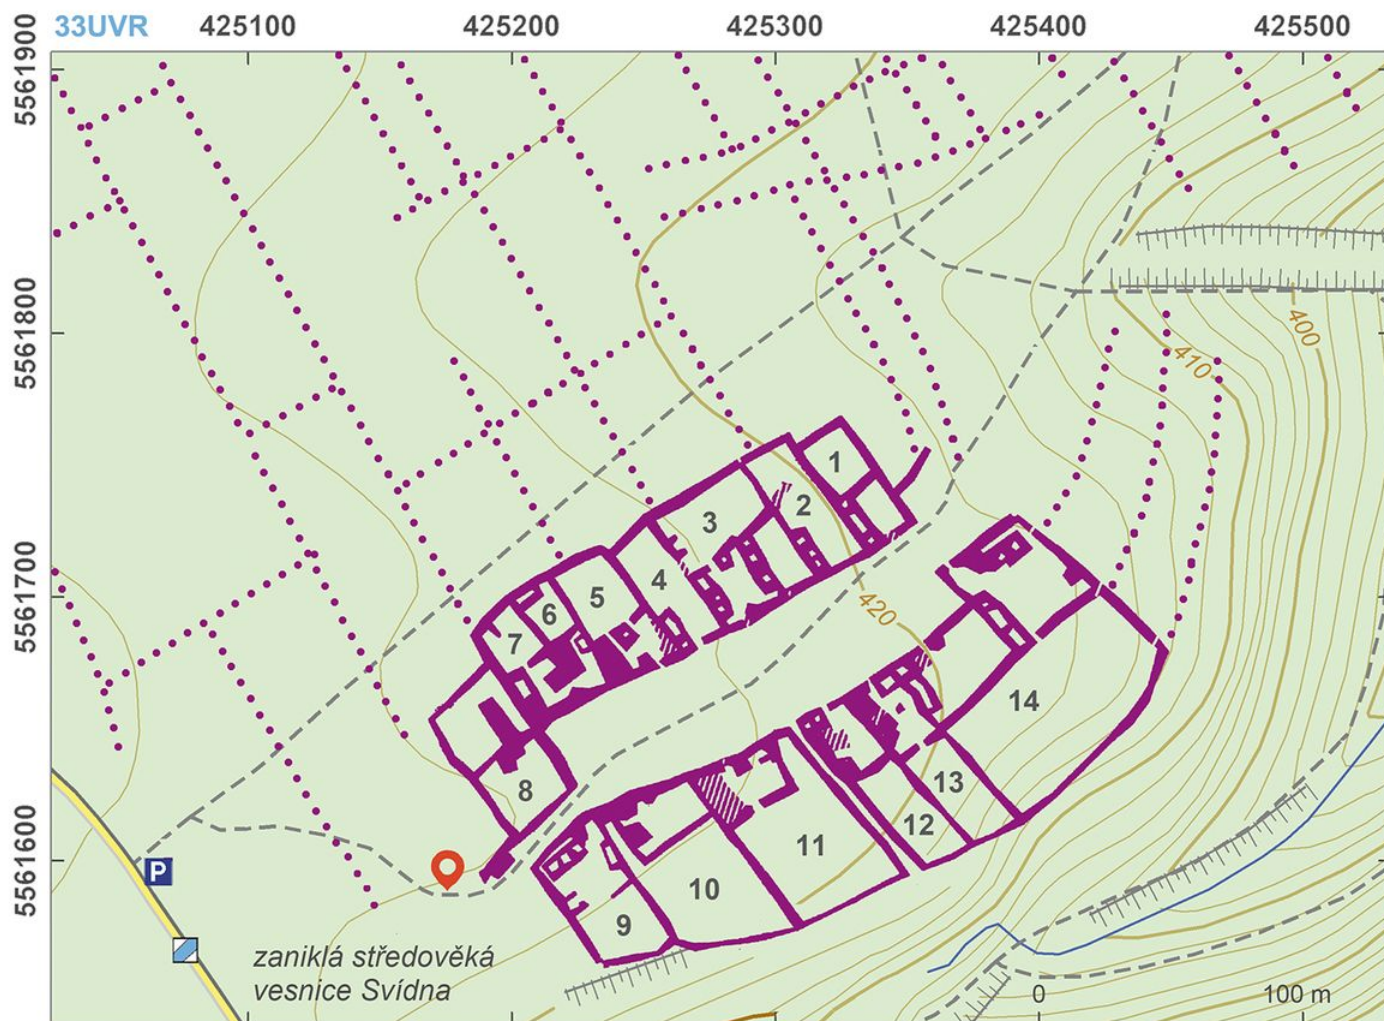
Site plan.

Map notes: 1–14 – plots of the original homesteads.

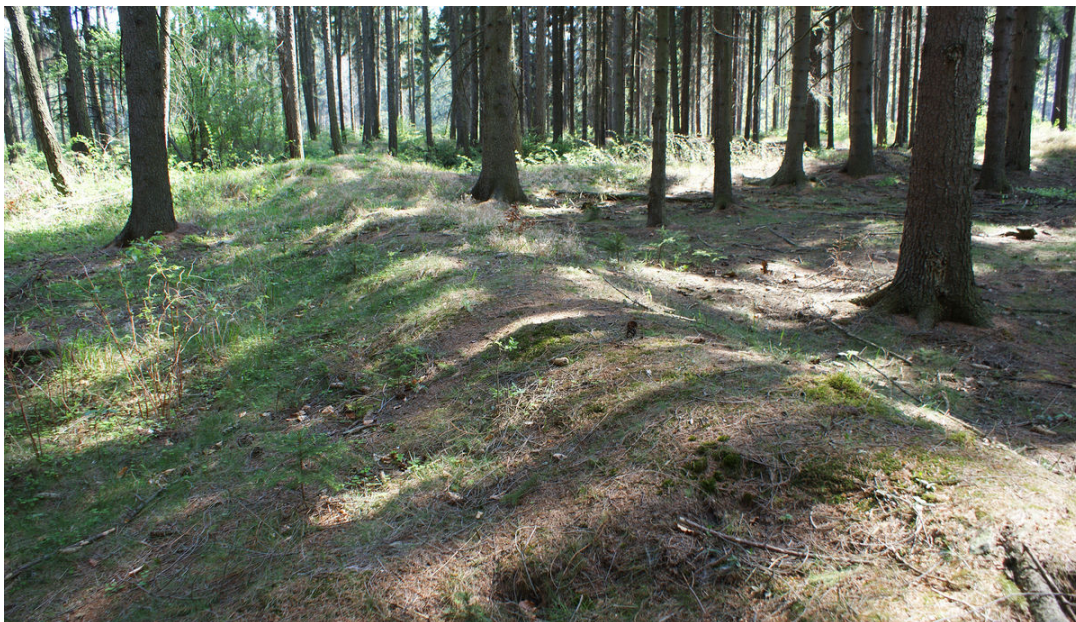
Homestead Nr. 14, walls.

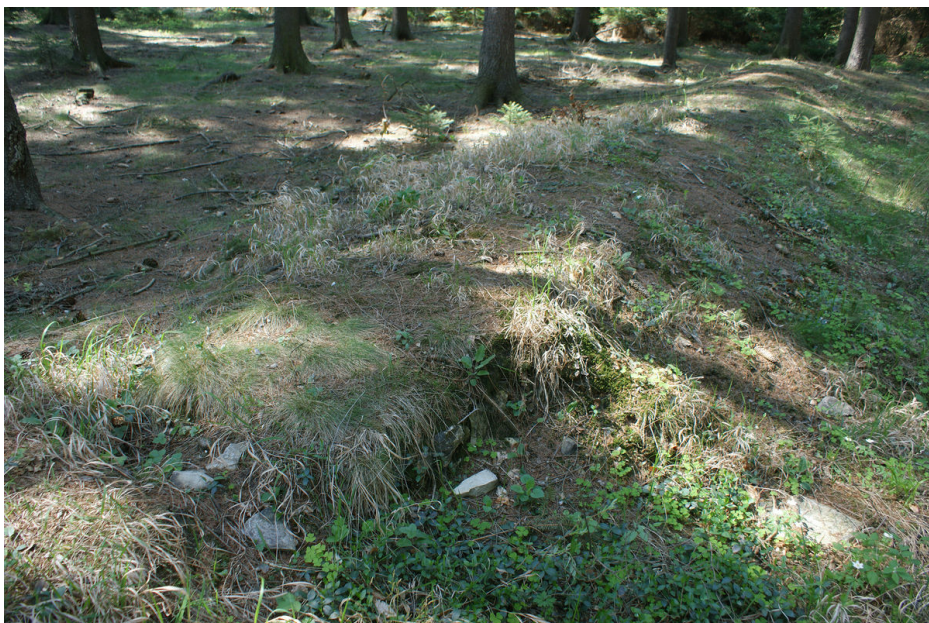
Homestead Nr. 14, walls.

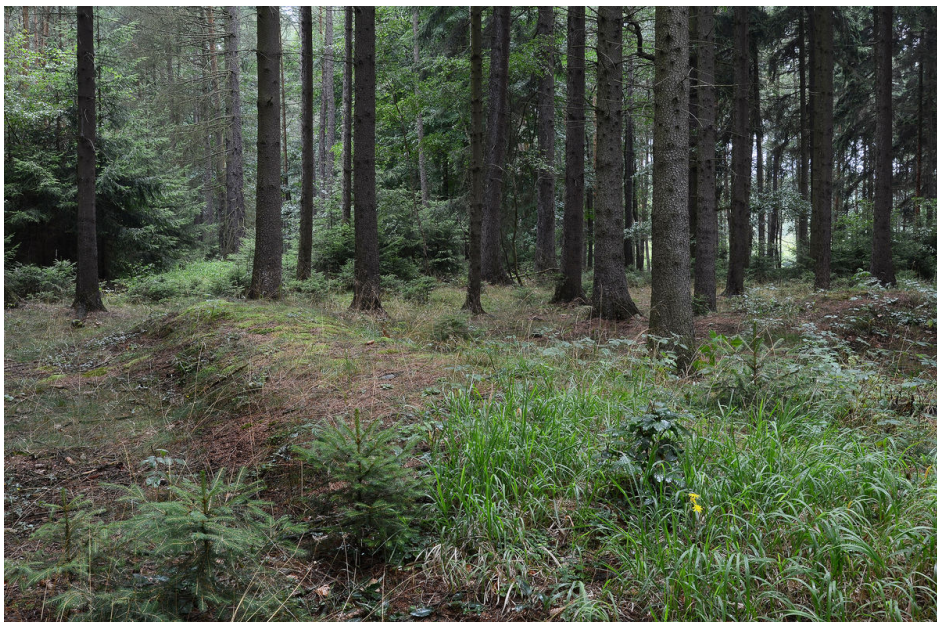
Medieval deserted village ruins.

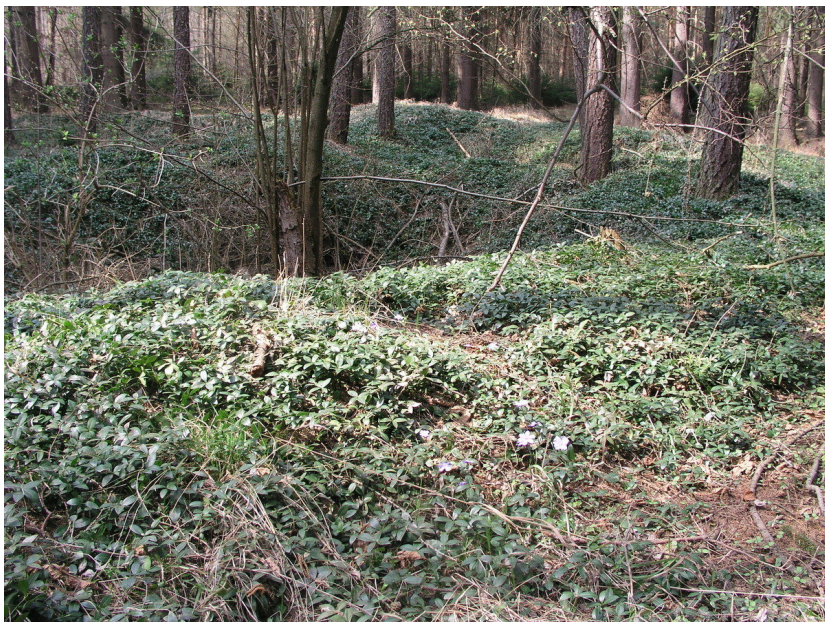
Unstable terrain covered by periwinkle - probably remains of a Medieval garden.

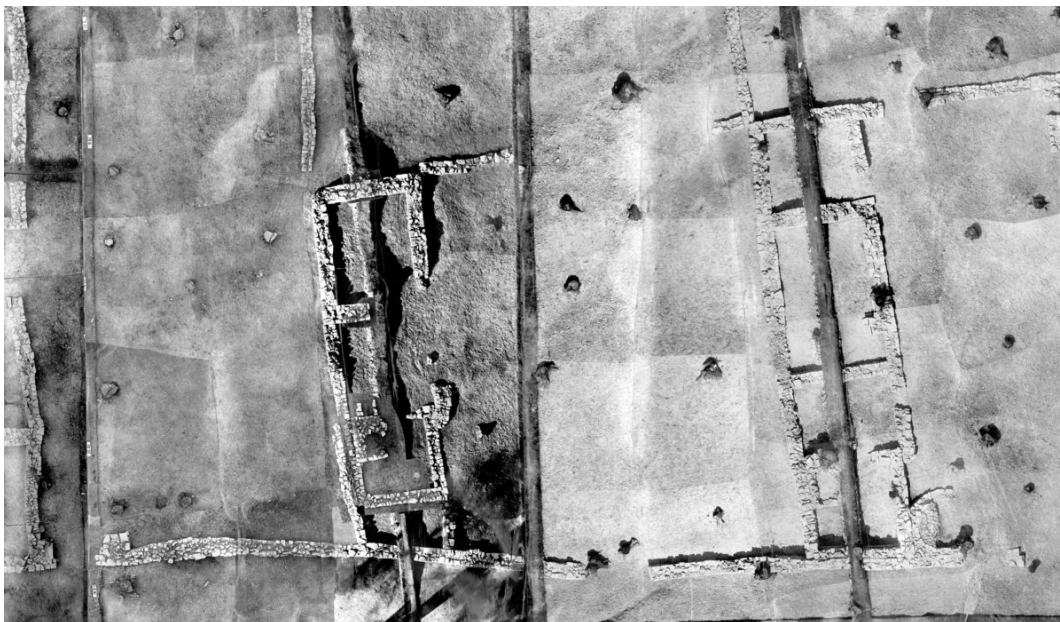
Photoplan of houses Nos. 1 and 2 during archaeological field work.
Archives of the IoA, PY000228019.
