# Prague-Hradčany, Prague

## Early Medieval centre of Prague Castle

(9th–12th cent.)

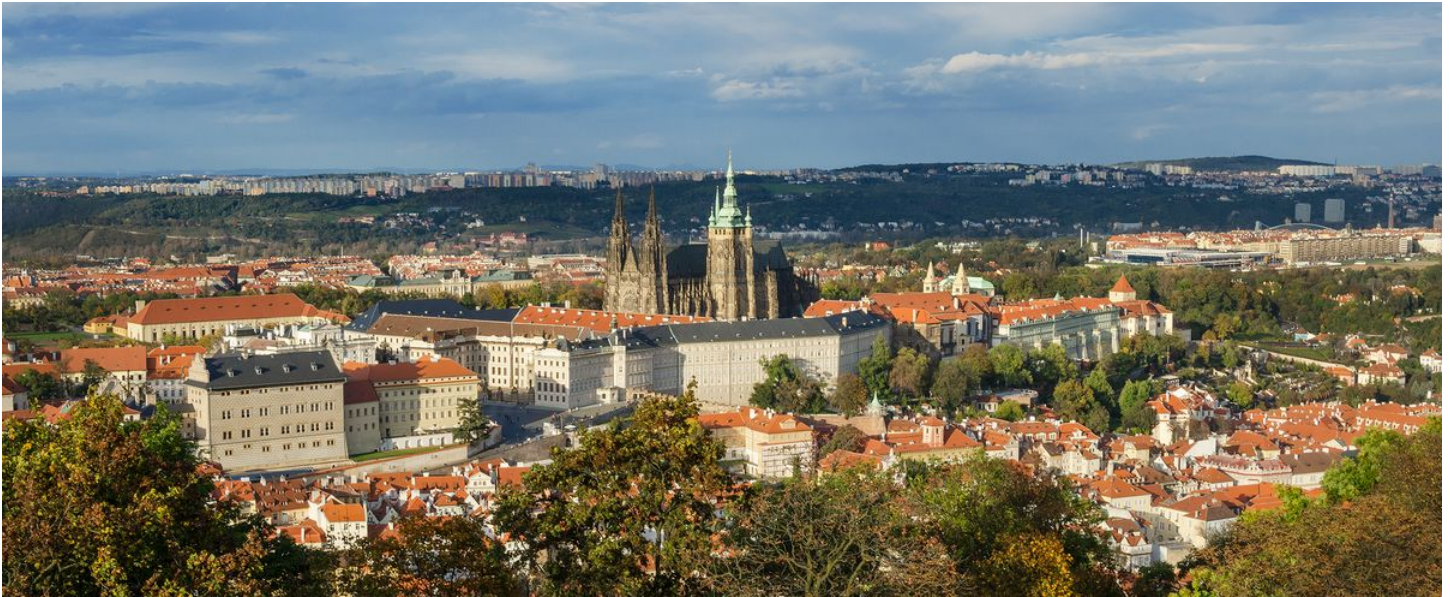
**Map notes:** A – Church of the Virgin Mary; B – uncovered parts of 'Romanesque' fortification (violet lines); C – Rotunda of St Vitus; D – northern apse of the rotunda added in the 11th century; E – Basilica of St Vitus; F – St George's Basilica.

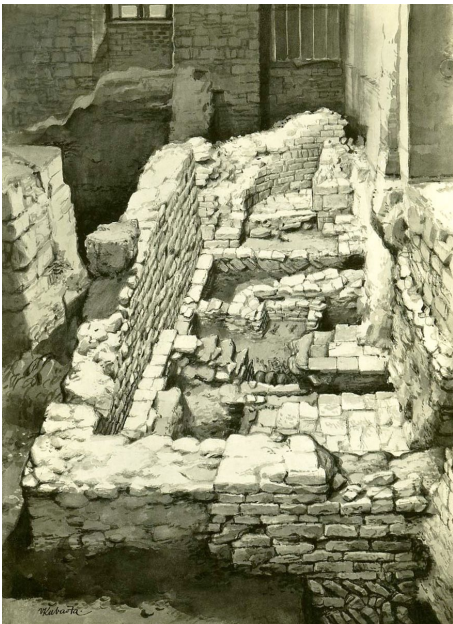
Remains of Our Lady church after its discovery in 1950.  
Painting by V. Kubašta.

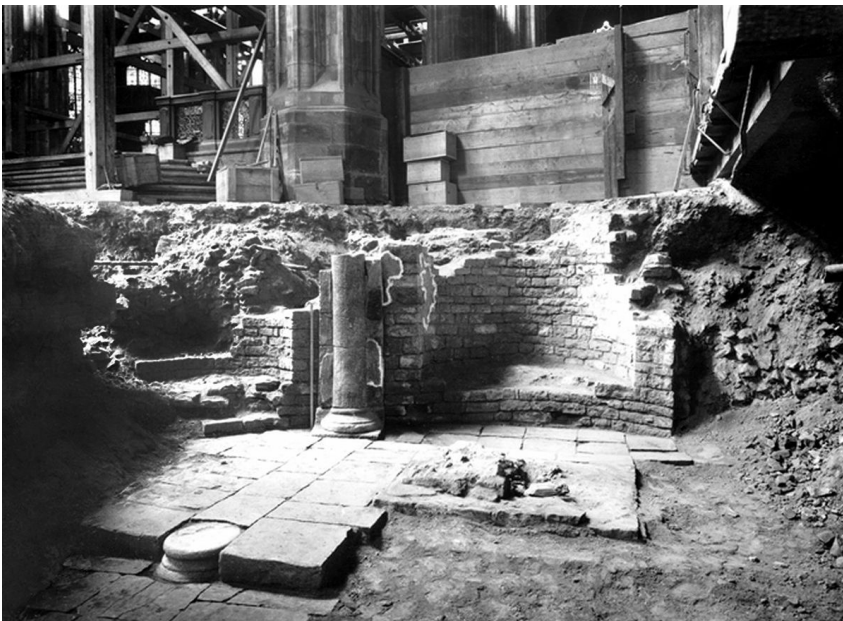
Eastern apsis of St. Cosma and Damian crypt after its discovering by K. Hilbert.  
Prague Castle Archives, 1928.

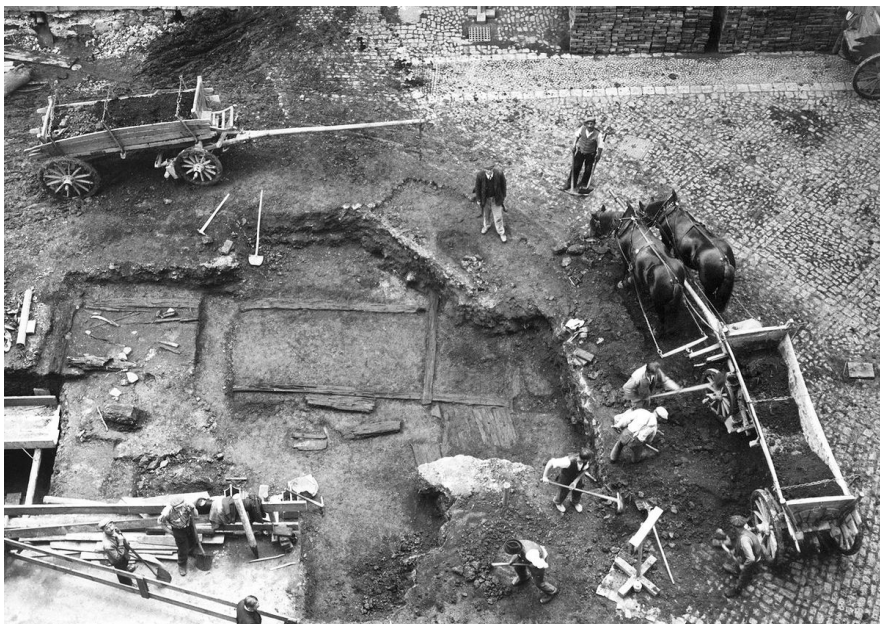
Wooden houses construction found during 1920s archaeological excavations on the Third Castle Courtyard.  
Prague Castle Archives, 1929.

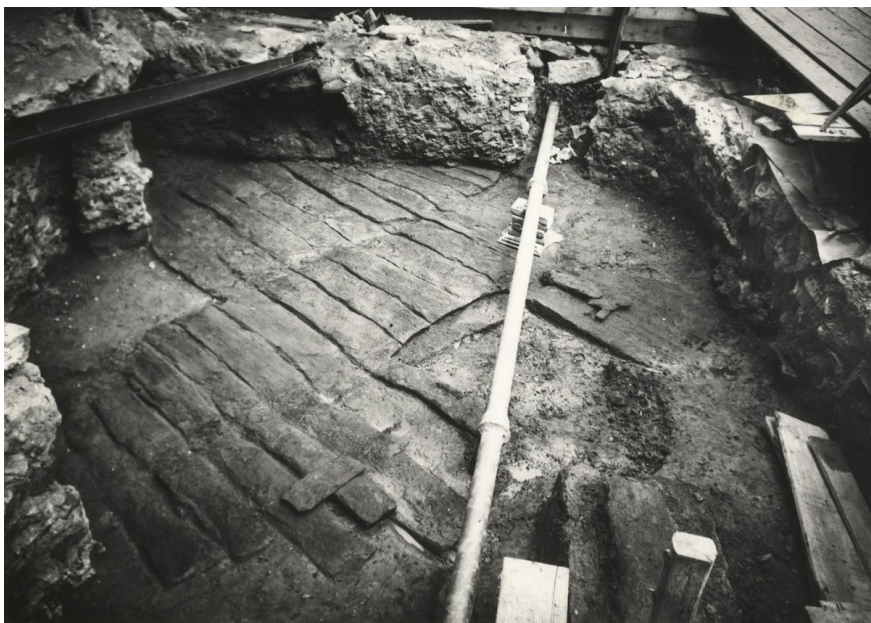
Road paved with wood from the 10th century found beneath the III Courtyard.  
Prague Castle Archives, 1927.

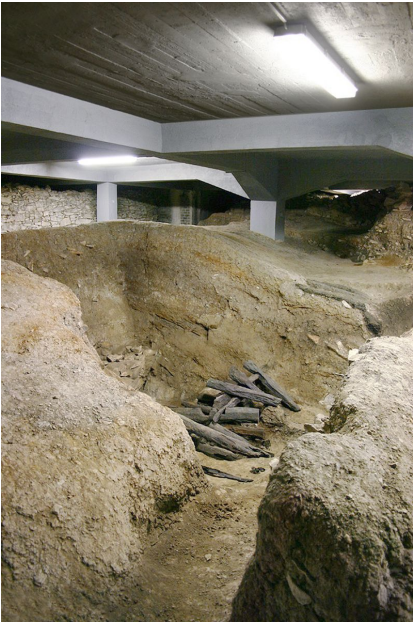
Remains of wooden construction of the Early Medieval fortification from 10th century beneath the Third Castle Courtyard.
