Chlístovice, Kutná Hora dist., Central Bohemian Region

Medieval castle 'Sion' and the adjacent siege camps

(15th cent.)

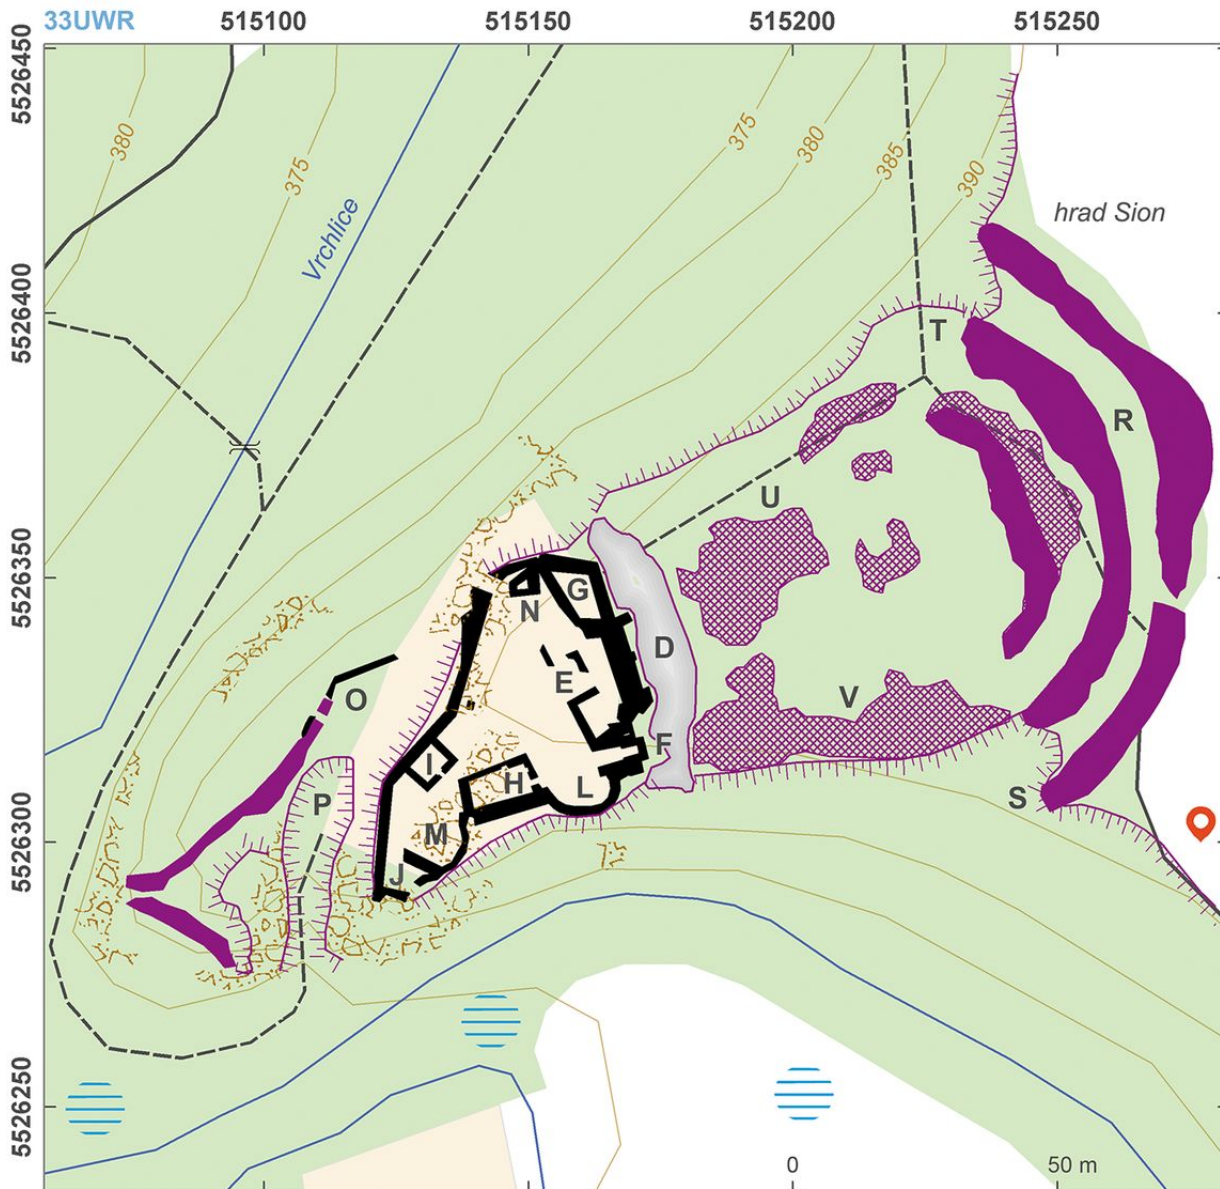
Site plan.

Map notes: A – castle; B – bailey; C – siege camp; D – neck ditch between the castle and bailey; E – built-up area of castle; F – gate; G – remains of a timbered structure built on stone foundation; H – palace; I – castle kitchen; J – another residential building?; K – Church of St Andrew; L–N – bastions; O – platform outside of the castle, later attached by fortifications; P – ravine with access to stream; Q – pond; R – bailey fortifications; S – bastion formation; T – relief edge enclosing the northern part of the ditch; U – remains of structures within the bailey; V – remains of production structures; W – one of the siege camp areas demarcated by a ditch and a bank; X – command station or catapult position; Y – catapult firing position and remains of dwellings and operational buildings; Z – additional siege camp structures (e.g. 'wolf pits').

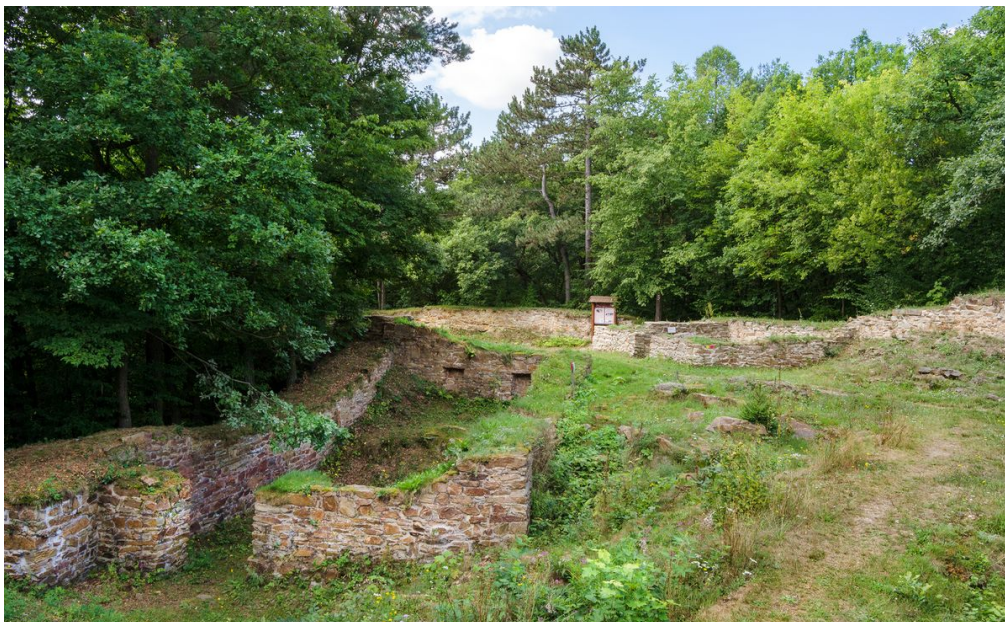
Castle core, taken from north-east. A palace (left), castle kitchen (in the background).

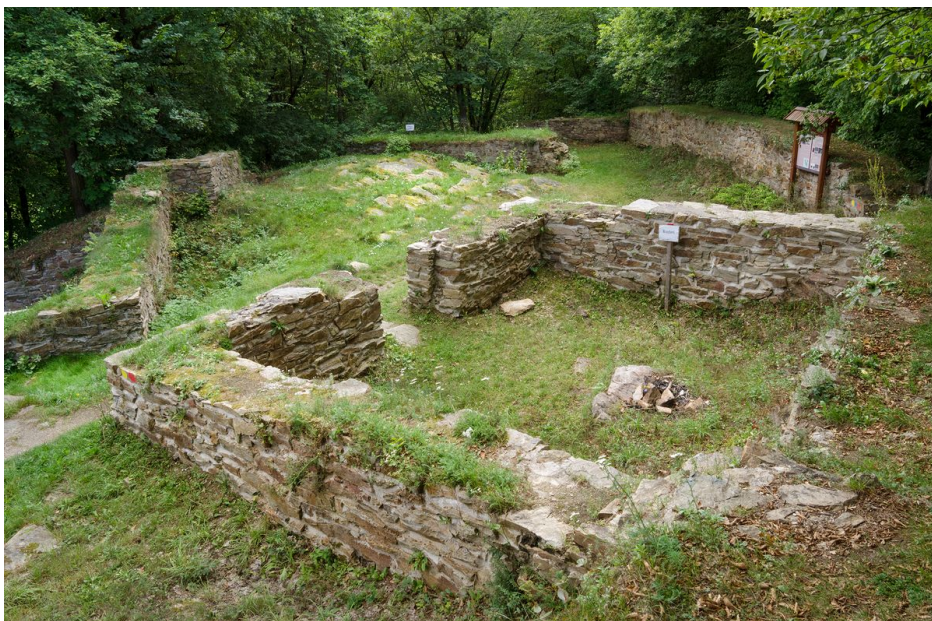
Castle core, taken from north. Kitchen (in front), palace corner (left).

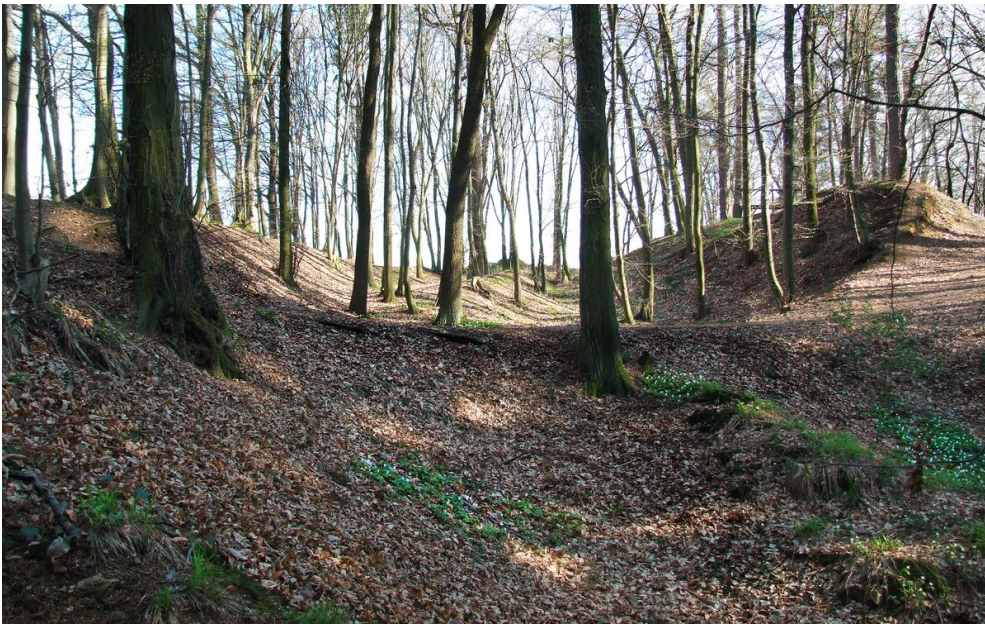
Fortification in front of the castle areal from north-east.

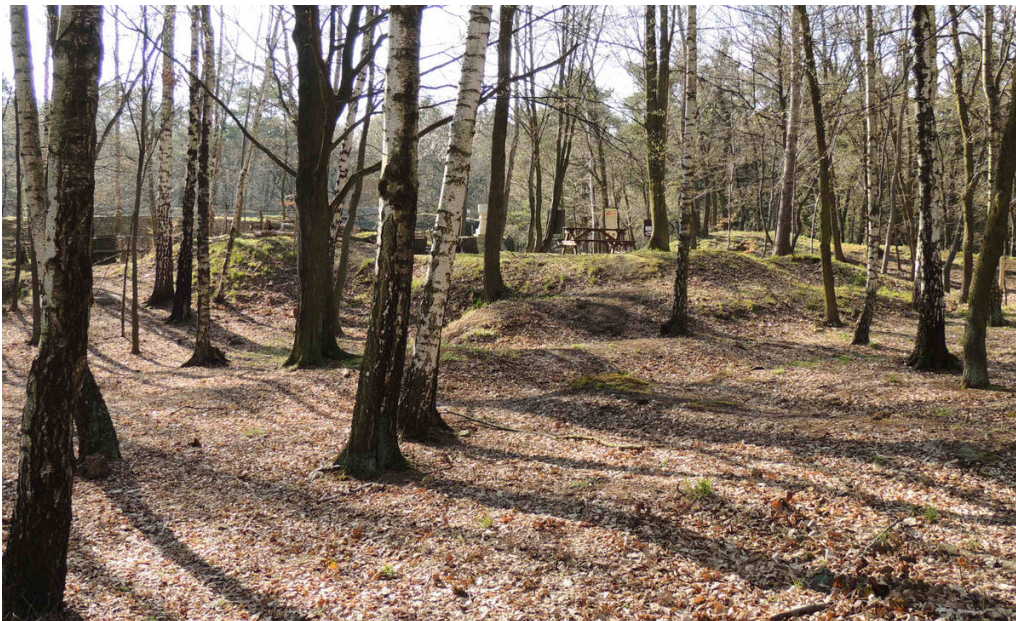
View across the bailey on the castle's core, taken from northeast.

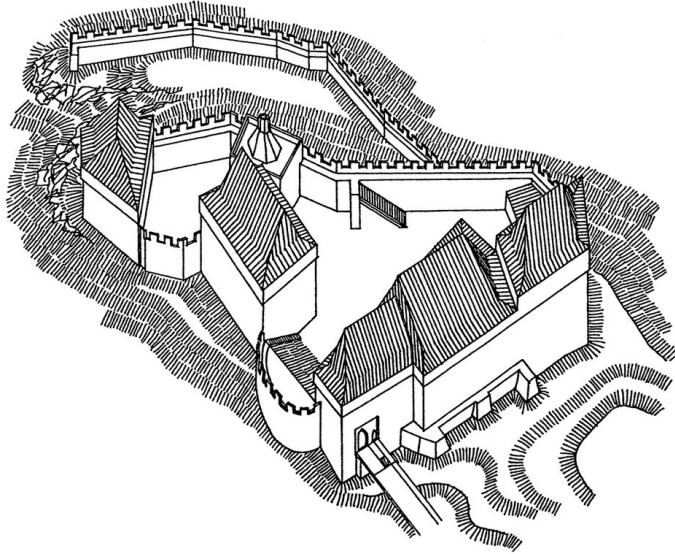
Drawn reconstruction of the castle.
