Lelekovice, Brno-Country distr., Southern Moravia Region

Medieval castle Lelekovice

(from mid-14th cent. to the beginning of the 15th cent.)

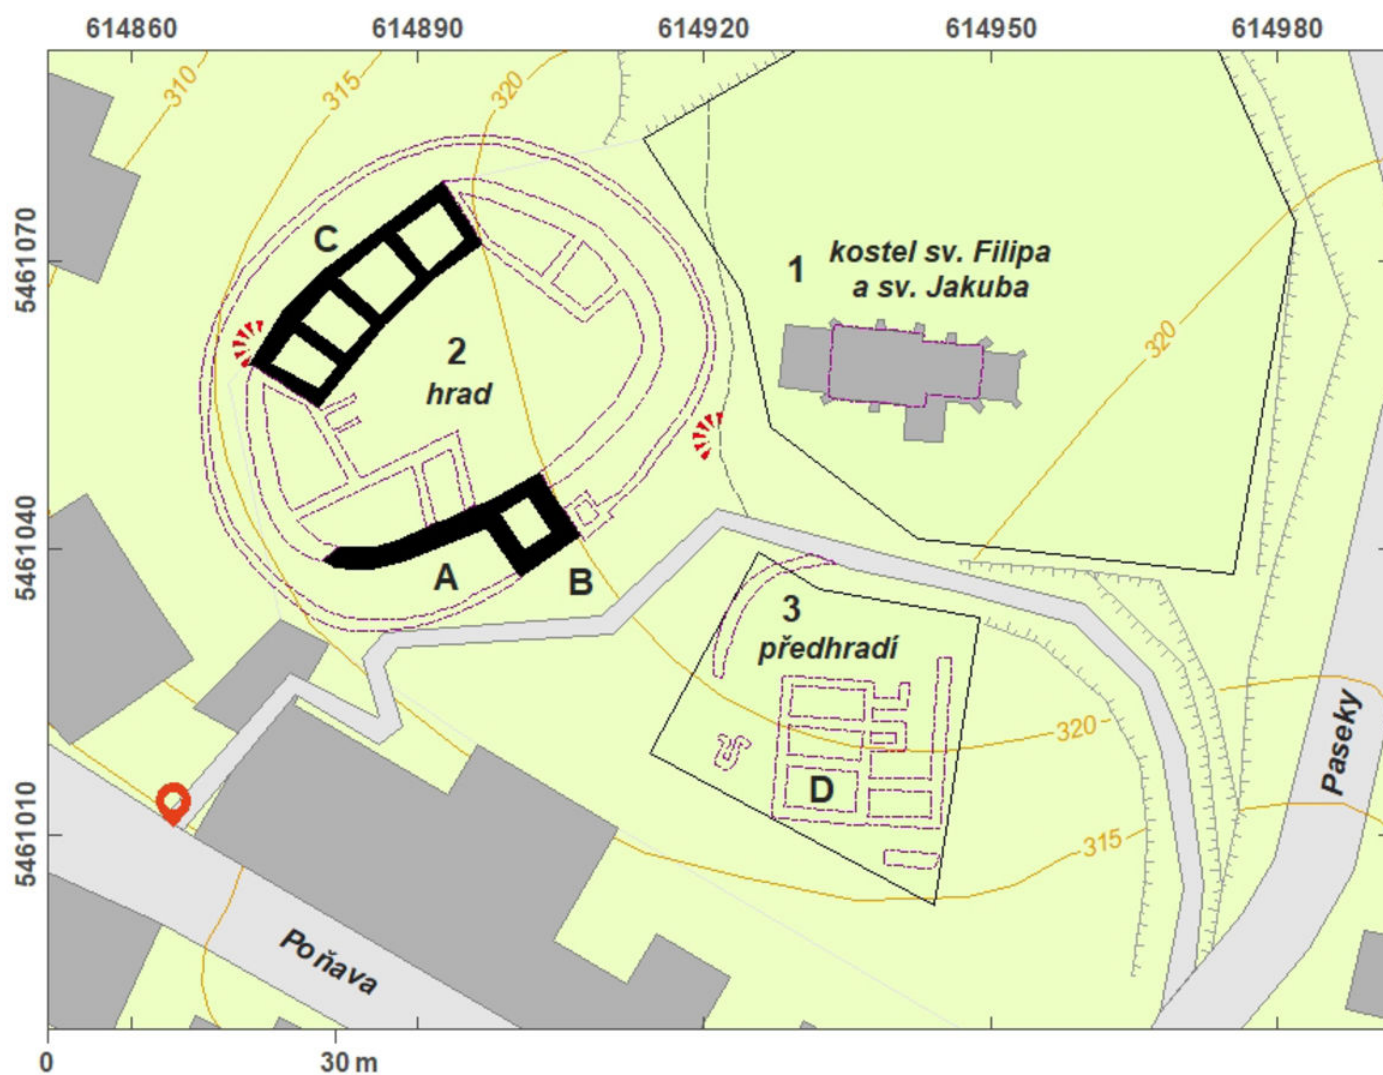
Site plan.

Map notes: 1 – Church of St Philip and St Jacob; 2 – castle; 3 – lower ward; A – stone fortification wall; B – prismatic tower; C – four-room residential building; D – residential building in the lower ward.

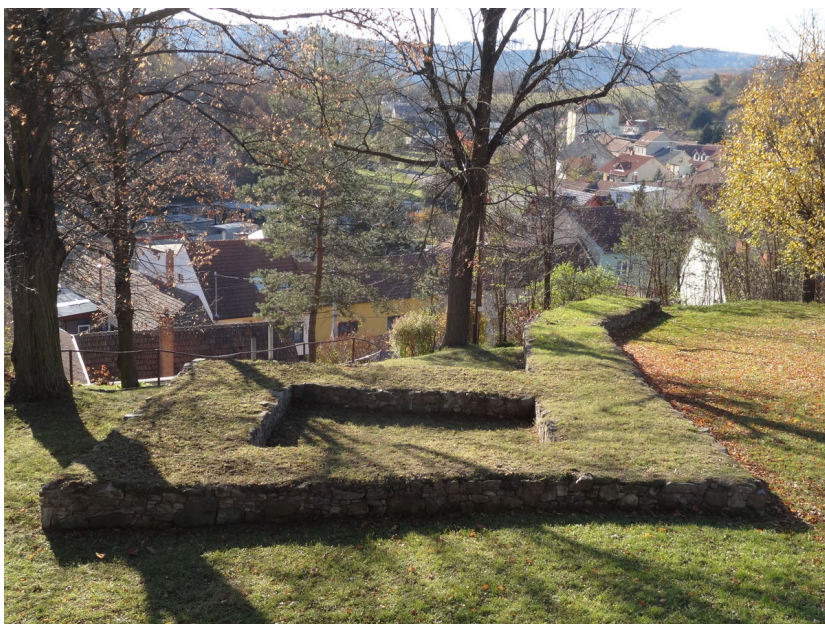
Presentation of the defence walls and a tower.
