Zlaté Hory in Jeseníky, Jeseník dist., Olomouc Region

Medieval castle Edelštejn

(13th-15th cent.)

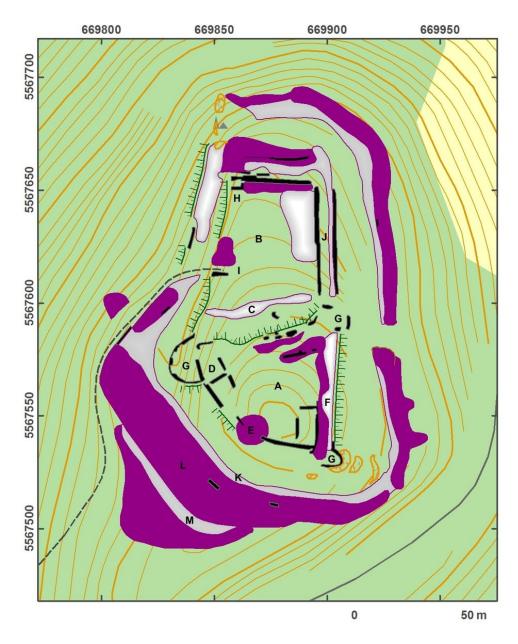
Site plan.

Map notes: A – upper ward; B – lower ward; C – ditch; D – reamins of buildings in the castle corner; E – bergfried; F – zwinger wall; G – corner bastions; H – fragments of a corner tower; I – remains of a gateway; J – zwinger; K – ditch; L – earthwork; M – neck ditch.

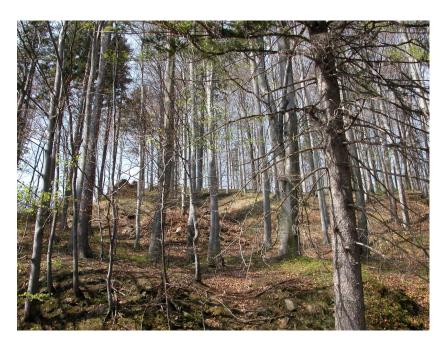
Bastion of the south court of the upper ward, view from the north-east. Photo H. Dehnerová.
